INDOOR AIR QUALITY REASSESSMENT

**Johnson Elementary School
290 Castle Road
Nahant, Massachusetts**

Prepared by:
Massachusetts Department of Public Health
Bureau of Environmental Health Assessment
February, 2002

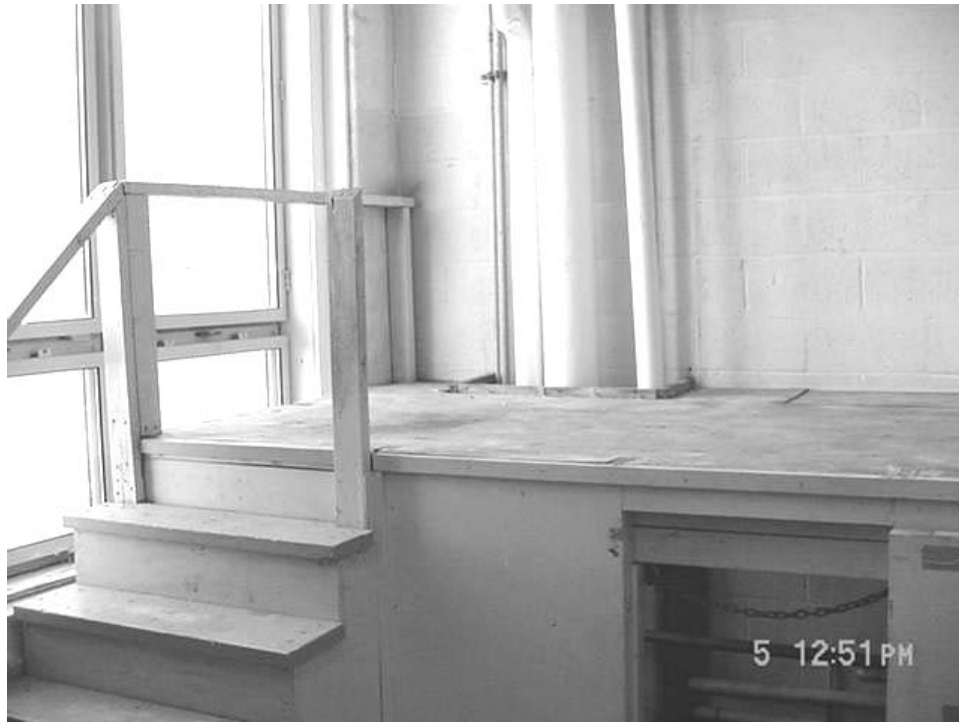
Picture 1

Action Taken: A number of the recommendations listed in previous BEHA correspondence were implemented to address microbial growth/relative humidity issues in the pump room. All water-damaged materials were removed/replaced and no microbial growth was observed during the reassessment (see Pictures 1-3).

Areas of Pump Room Previously Contaminated with Microbial Growth

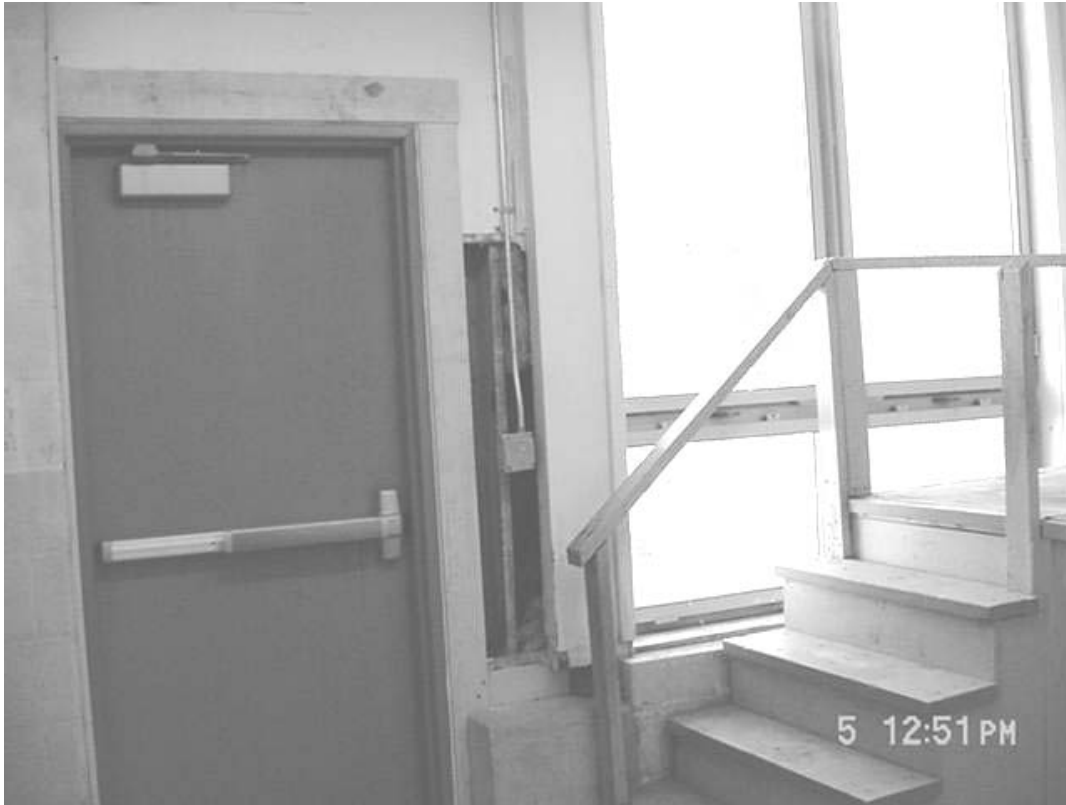
Picture 2

Areas of Pump Room Previously Contaminated with Microbial Growth

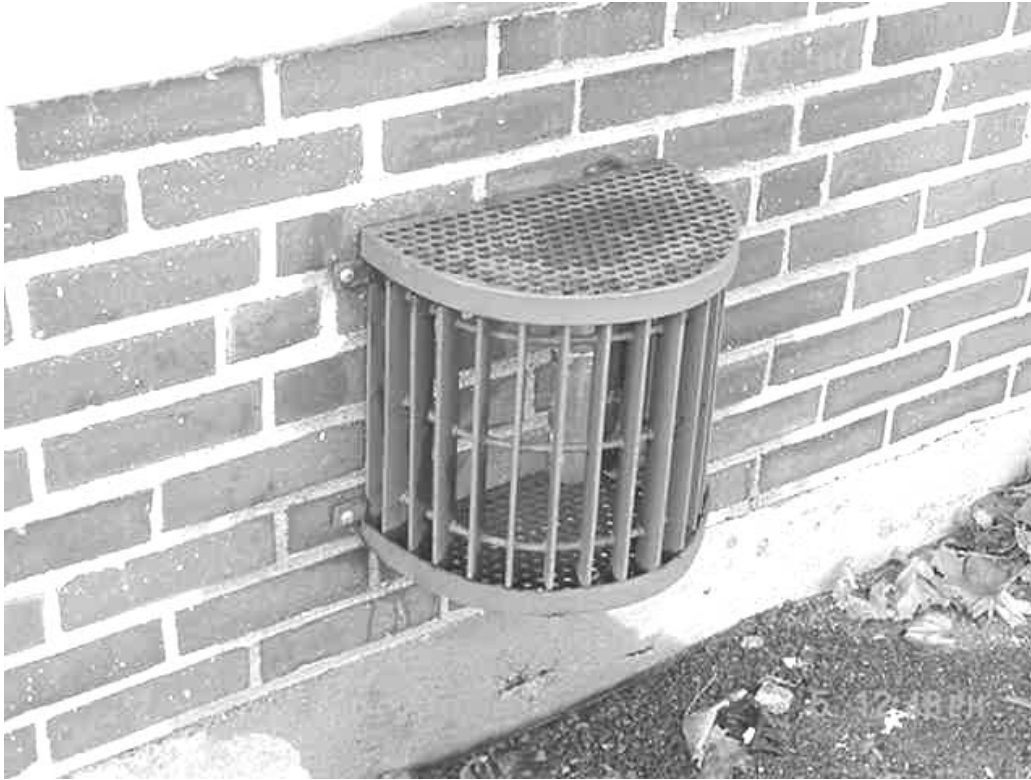
Picture 3

Steam Trap Released outside the Building, Previously Released inside the Pump Room

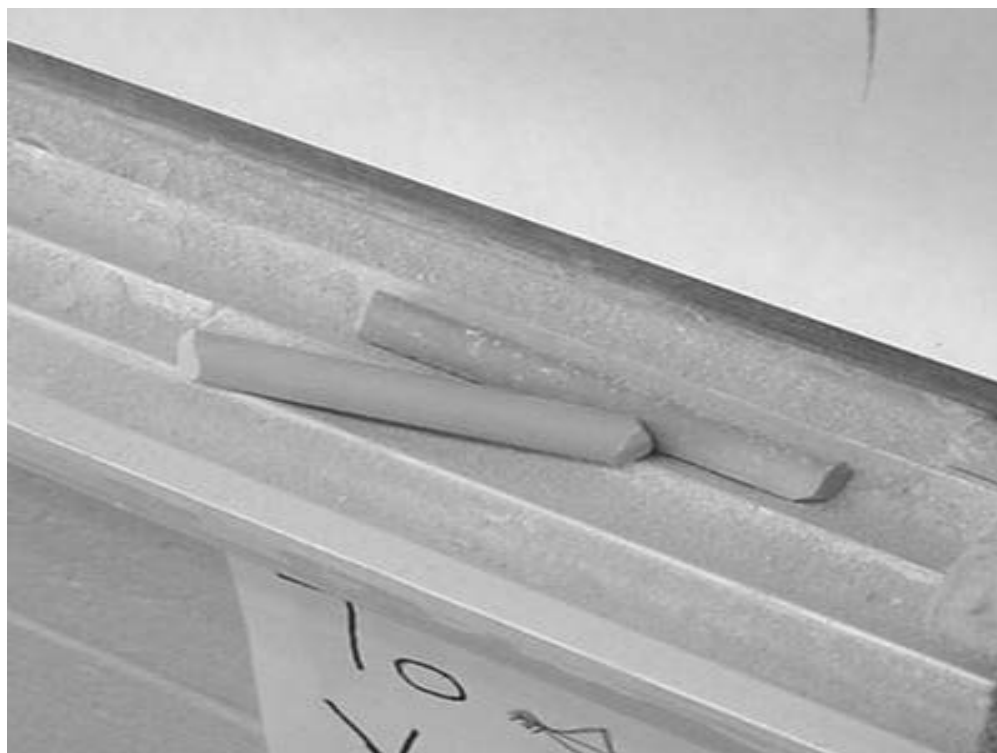
Picture 4

Action Taken: Staff were instructed by the school department to clean chalkboards. Adherence to this advice was apparent, however a few areas were observed to have accumulated chalk dust (see Picture 4).

Accumulated Chalk Dust in Classroom

- 13. Clean chalkboards and chalktrays regularly to prevent the build-up of excessive chalk dust.**
